## Home Inspection Report

XXXX XXXXXXX Drive  
XXXXXXXXXX, GA

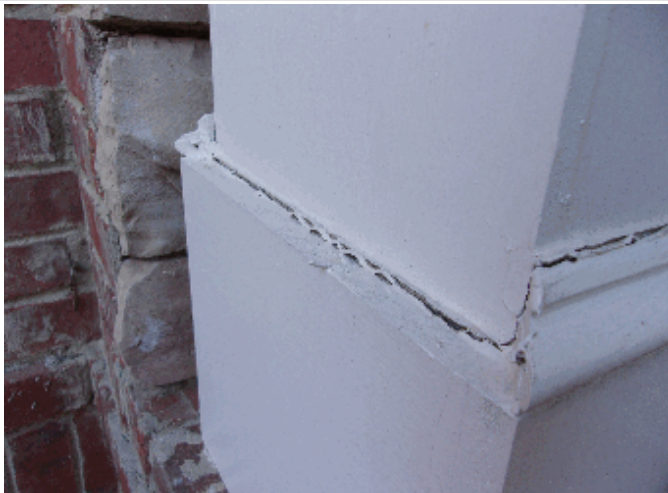
**Trim is missing on front porch column and it needs to be caulked**

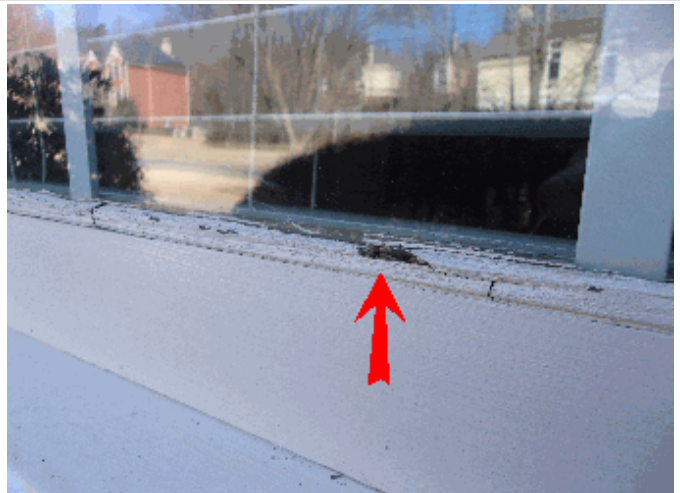
**Rotted window sash on lower left front window; other windows have some rot as well**

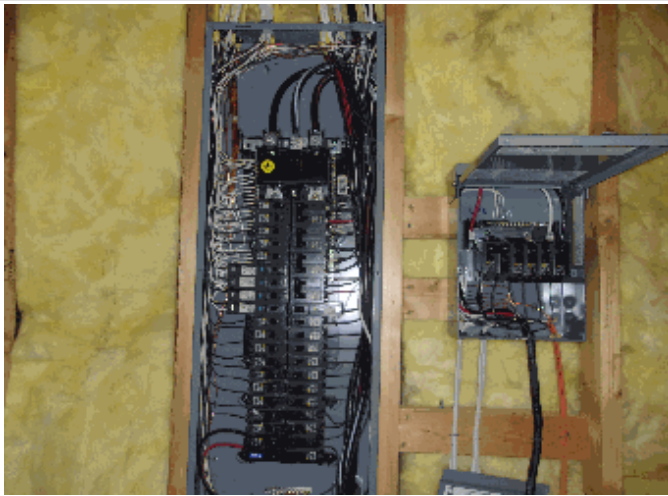
Panels - see image to right

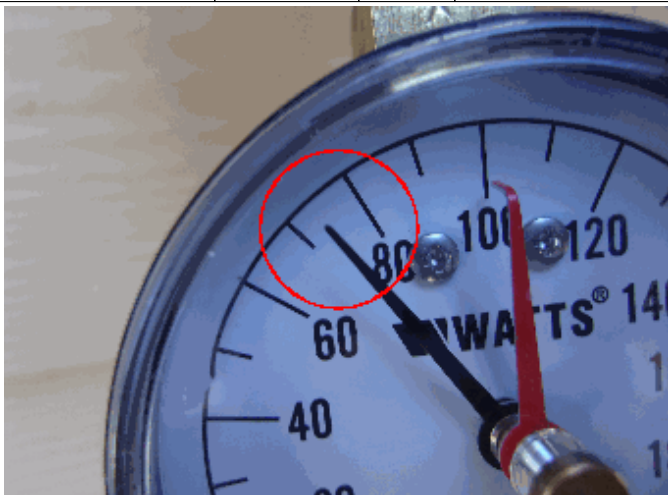
Water pressure at outside spigot

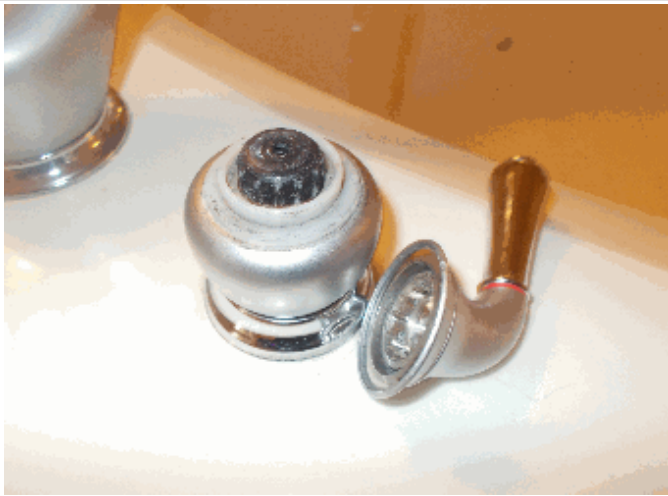
**Faucet handle is loose on the master tub**

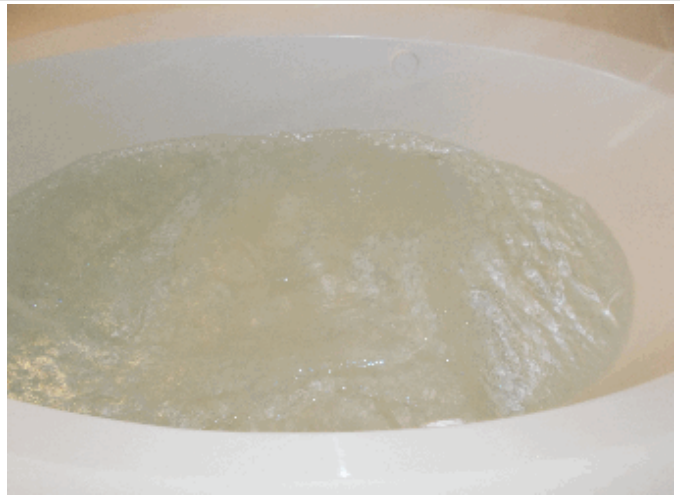
**Jetted tub operated in the master bath**

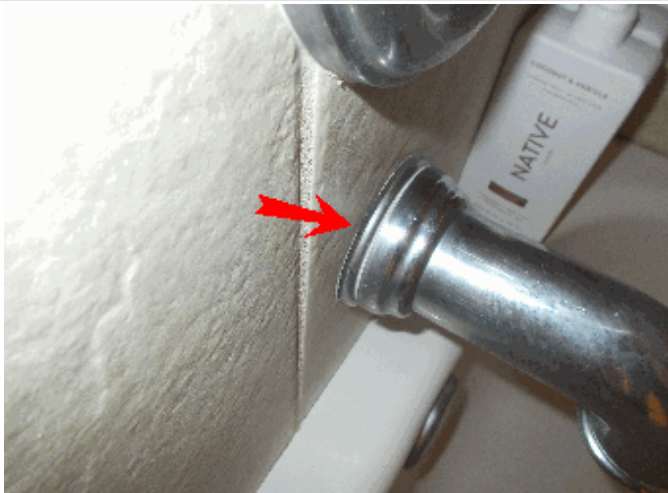
**We recommend caulking around the tub spigot in the Jack and Jill bath**

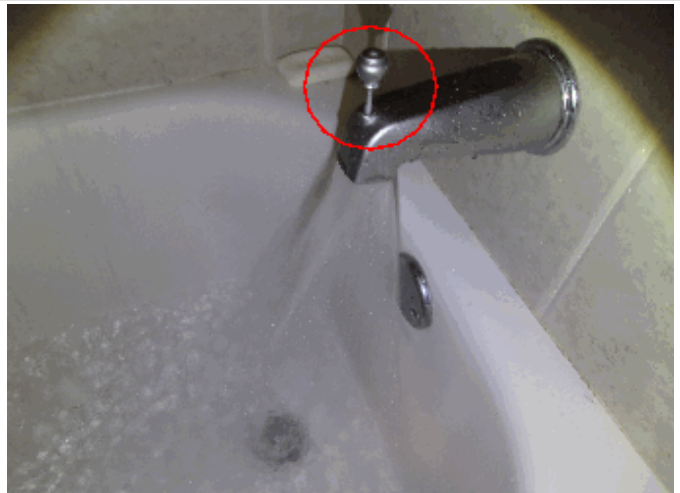
**Shower diverter would not close completely in the basement bath**

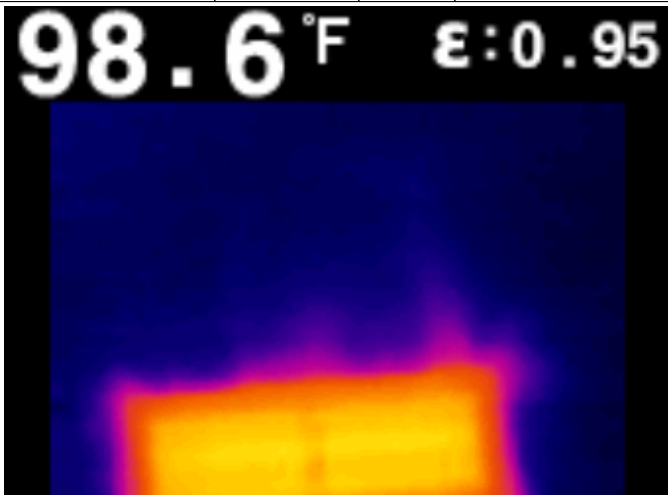
**Infrared image of vent shows heat working - all floors**

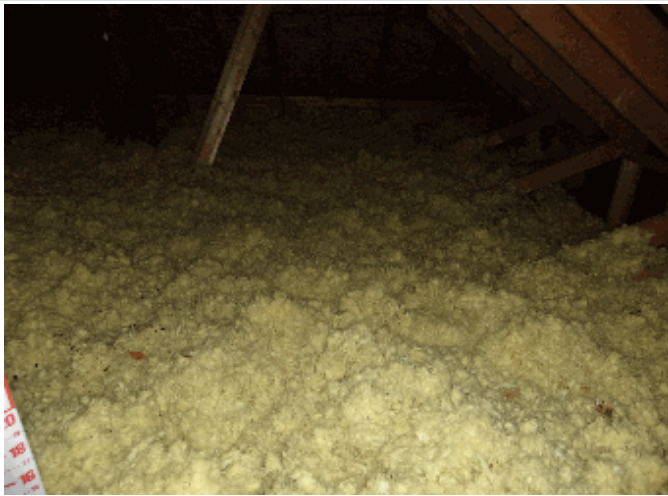
Attic insulation is adequate

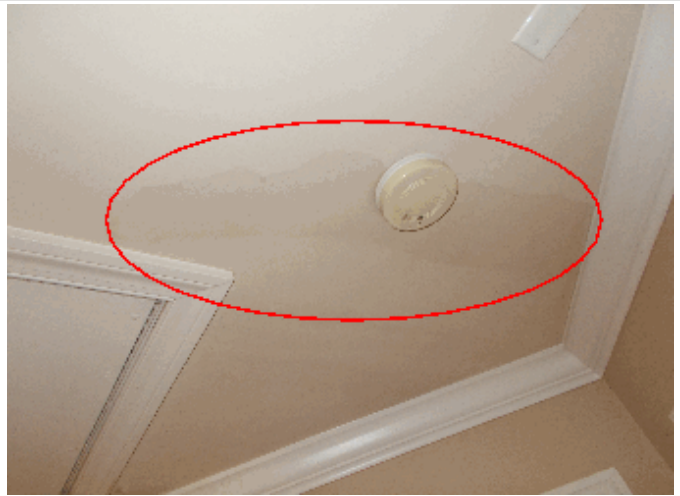
Stain near attic pull down - no moisture detected

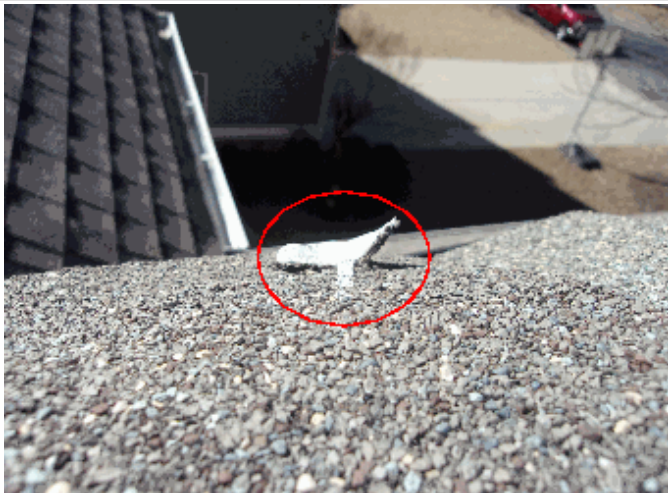
Areas of the roof will need to be resealed periodically

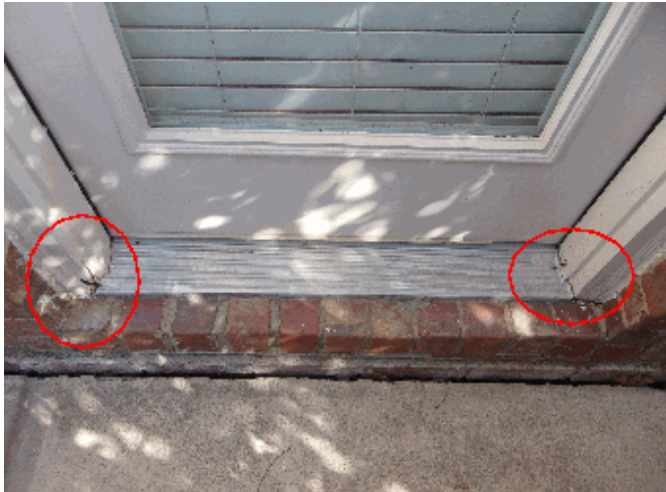
Structure: Rot on the garage man door jamb

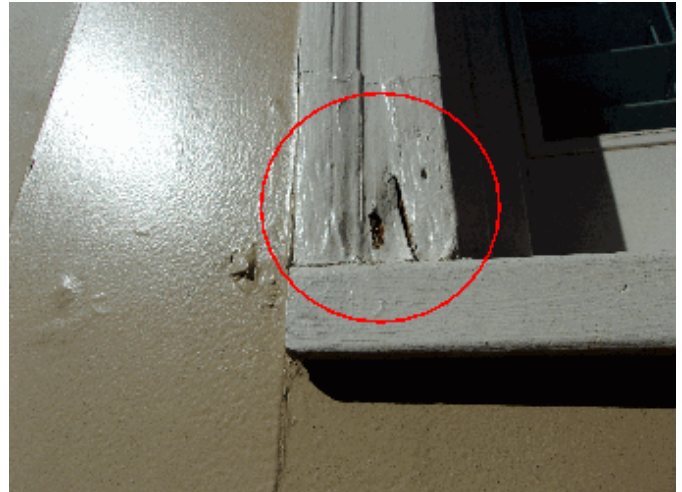
Structure: Trim rot on middle back bay window

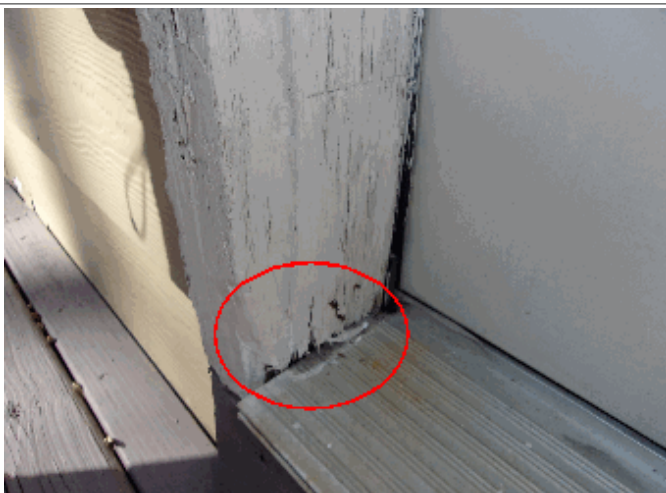
Structure: Rotted trim on the back deck door

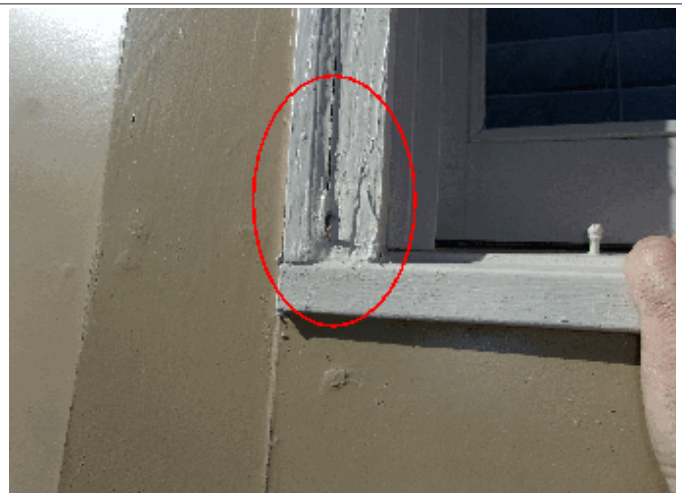
Structure: Trim rot on back left window

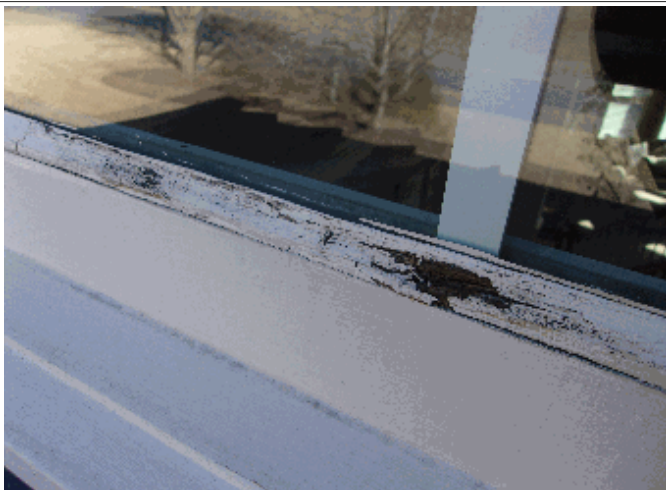
Structure: Rot on arch window above the front entrance

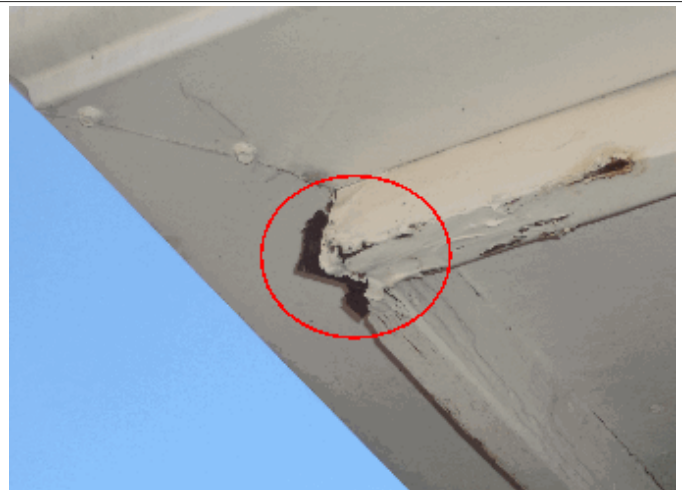
Structure: Fascia/soffit rot above the front porch

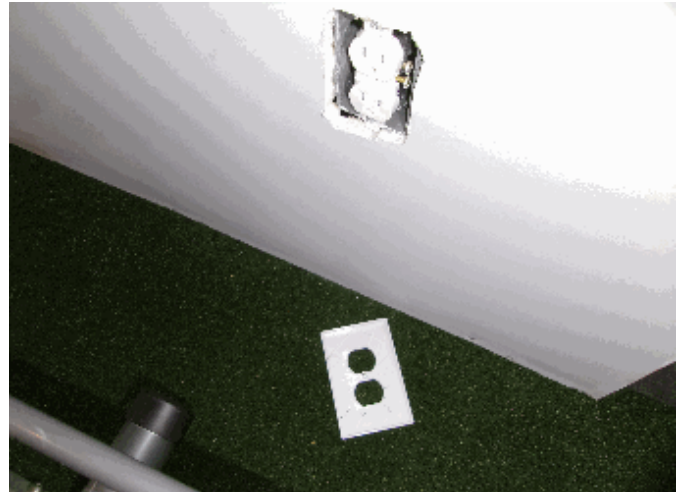
Electric: Receptacle in the basement is loose and needs the cover installed

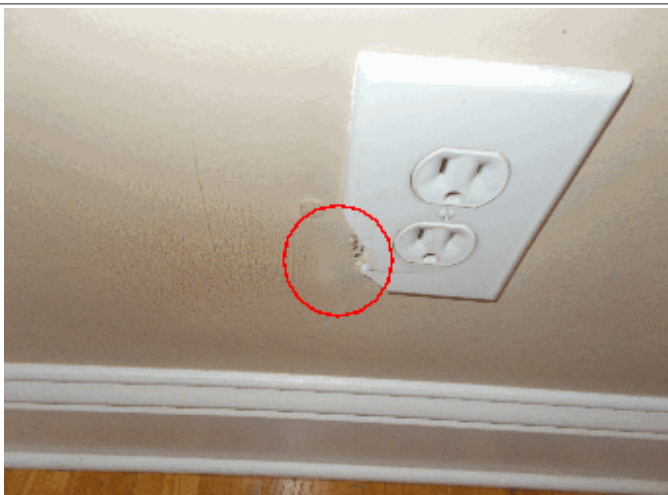
Electric: Broken cover on outlet in the foyer

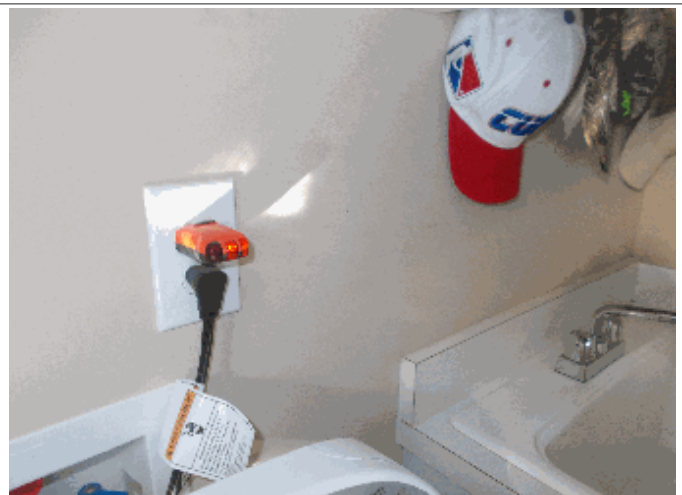
Electric: Outlet near the laundry sink is not GFCI protected

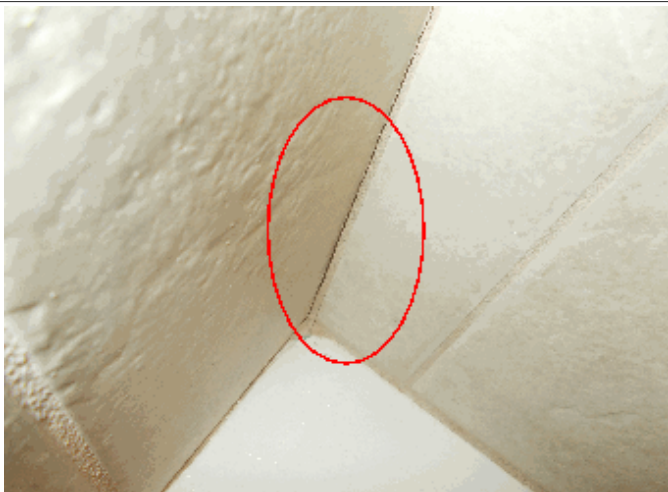
Baths1>2: You may want to seal the small cracks in the shower tile grout at some point

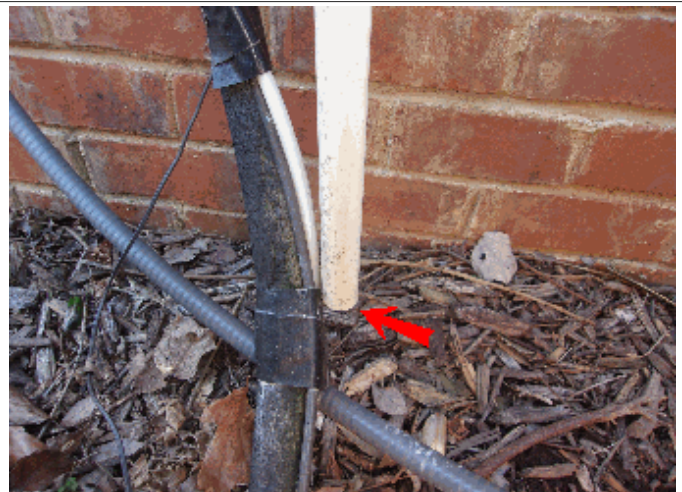
Heat: We recommend extending the HVAC condensation lines away from the house

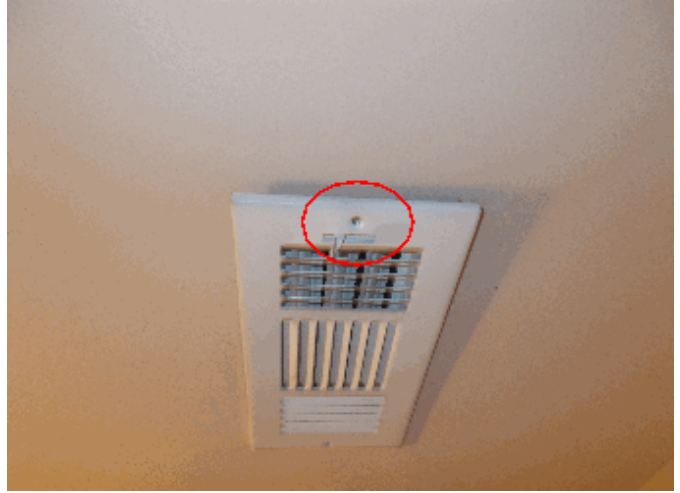
Heat: Screw missing on vent cover in the upstairs middle bathroom

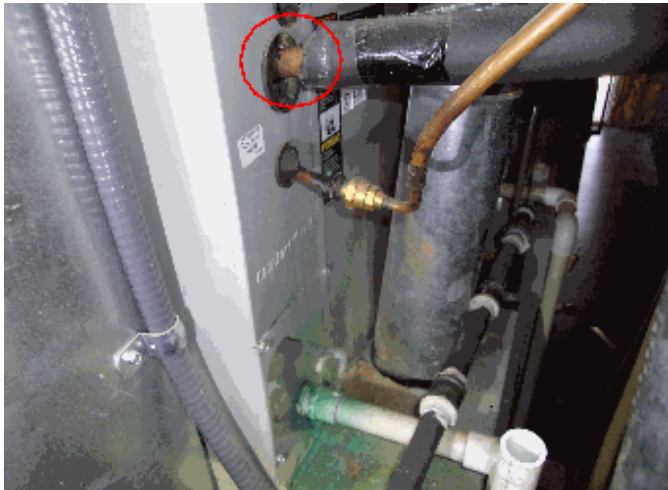
Heat: Line set should be insulated/sealed at the unit to prevent condensation - basement

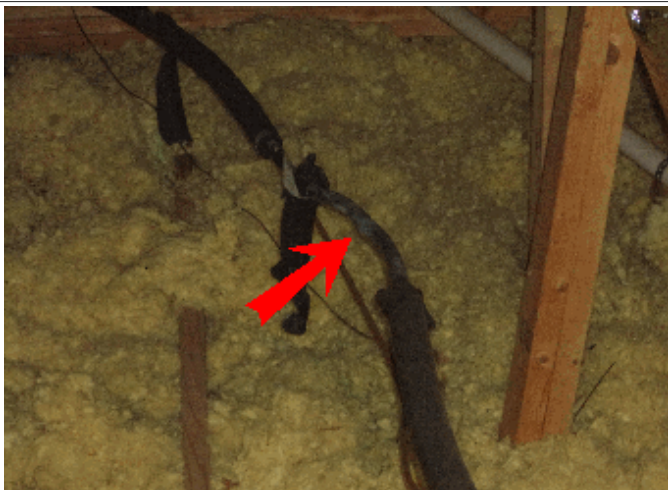
Heat: Section of the line set above the closet in the left upper front bedroom condensates causing ceiling stain

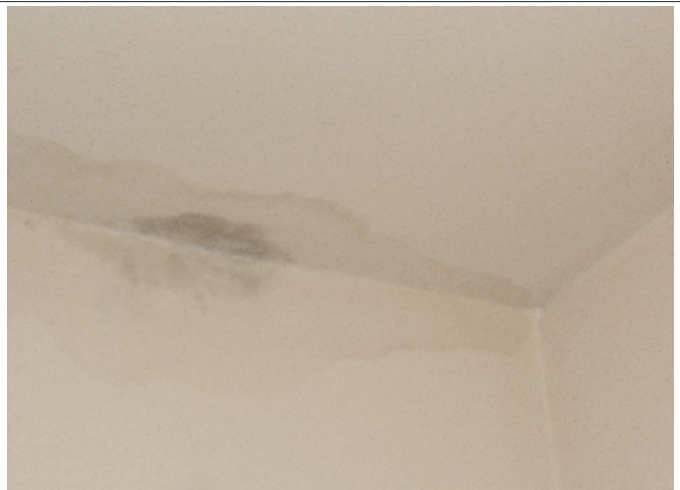
Interior: Stain in closet (upper front left bedroom) appears to be under line set that needs insulation

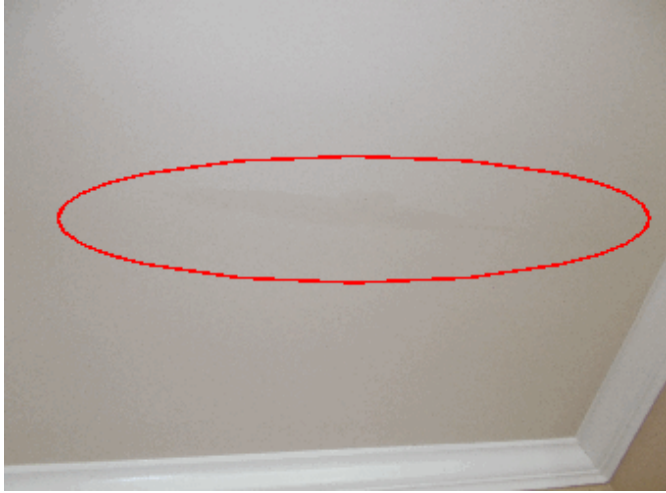
Interior: There are faint stains on the dining room and back left bedroom ceilings - no moisture reading

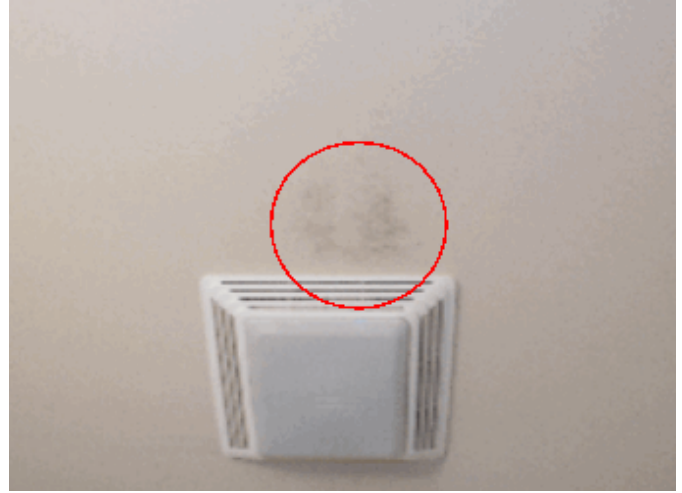
Interior: Stain on ceiling in the main floor bath appears to be from condensation

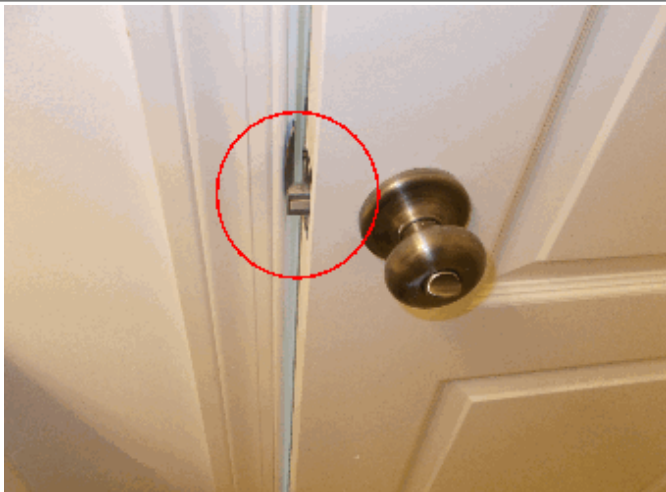
Interior: Two doors in the Jack and Jill bath would not latch

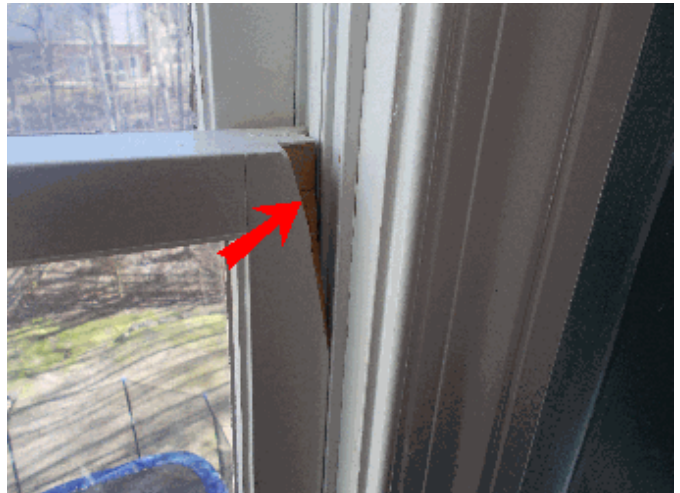
Interior: Piece of window sash is broken - back upper bedroom

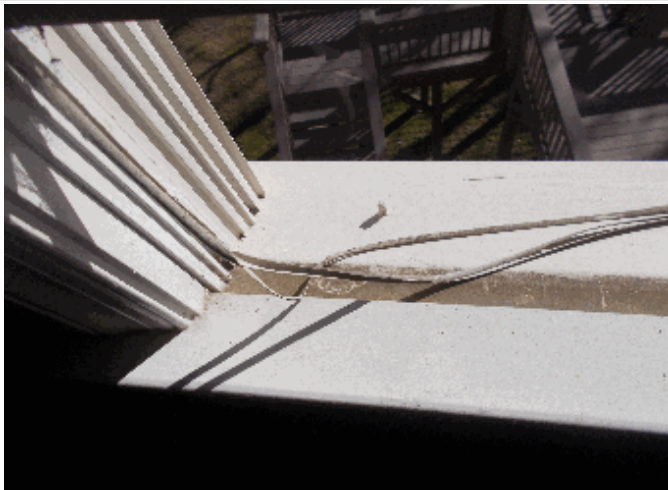
Interior: Loose bottom seals on back upper bedroom window(s)

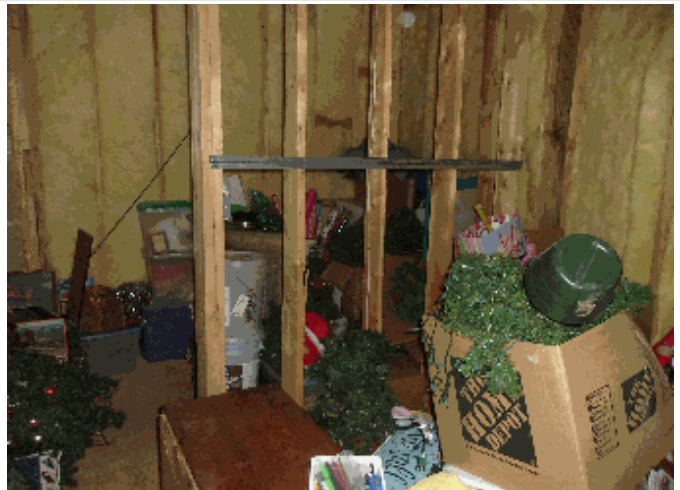
Interior: We had limited access to some areas due to storage

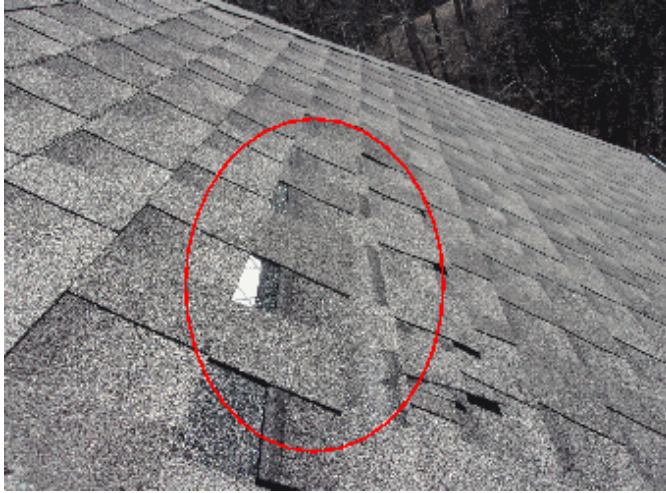
**Exterior: Row of shingles on the front needs to be reattached; this will cause a leak**

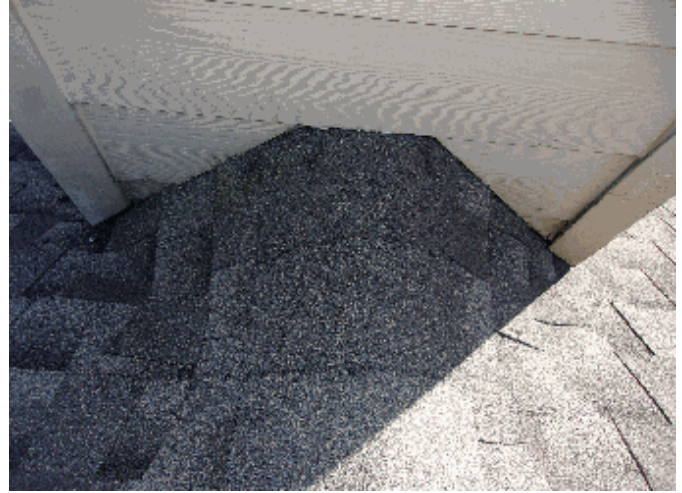
**Exterior: View behind chimney - OK**

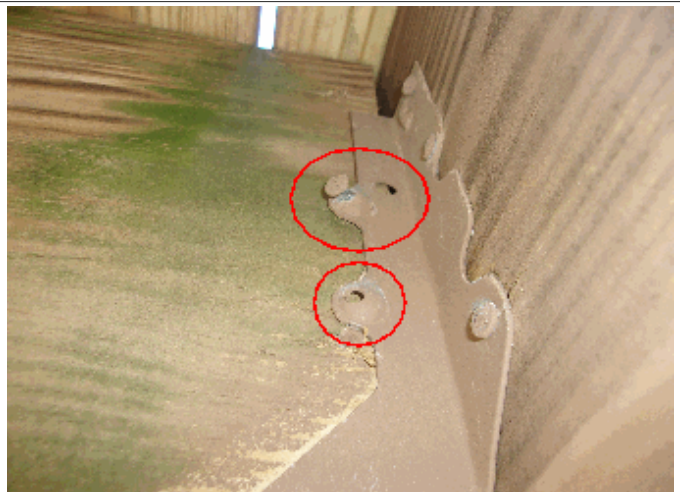
Exterior: Some of the nails on the deck joist hangers are missing and/or pulled away

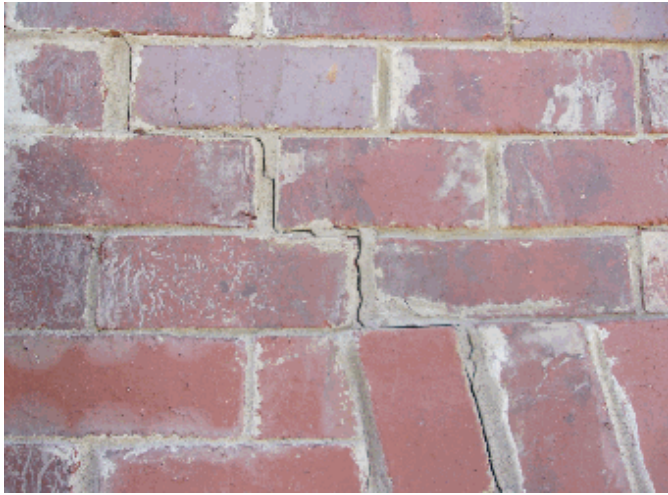
Exterior: Cracks in brick above the garage

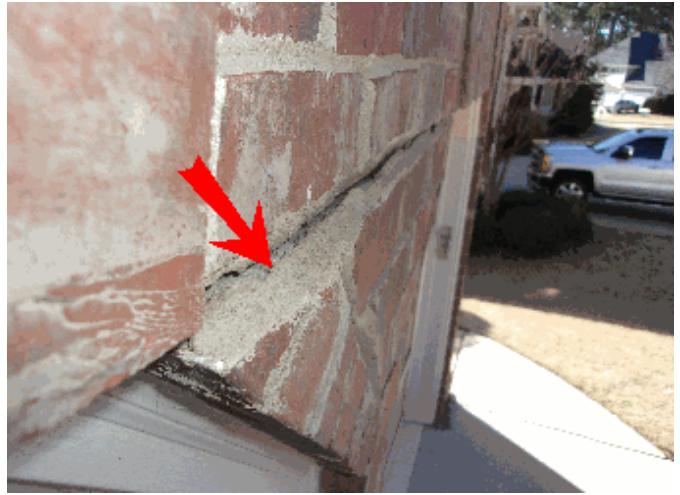
Exterior: Loose/offset brick above the garage

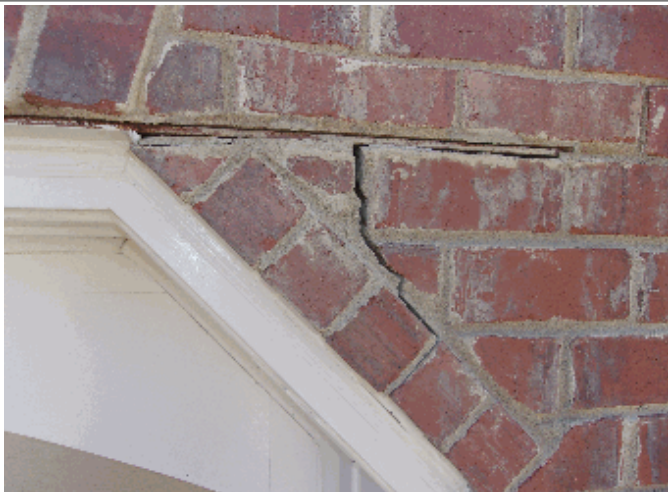
Exterior: Loose brick above the right side of the garage should be secured and sealed

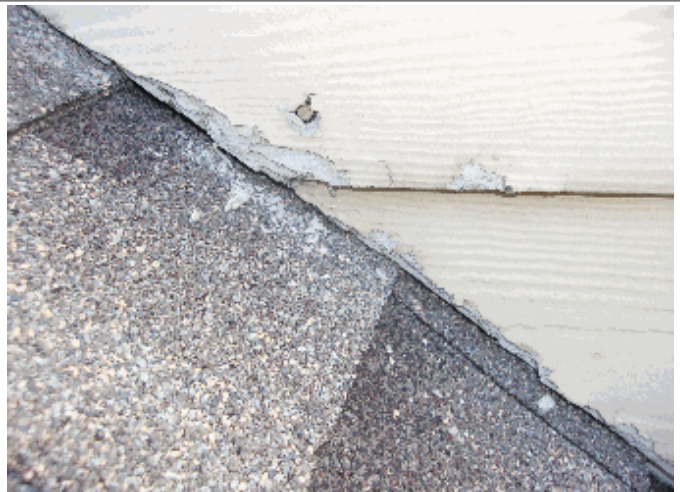
Exterior: Deteriorated siding above the roof

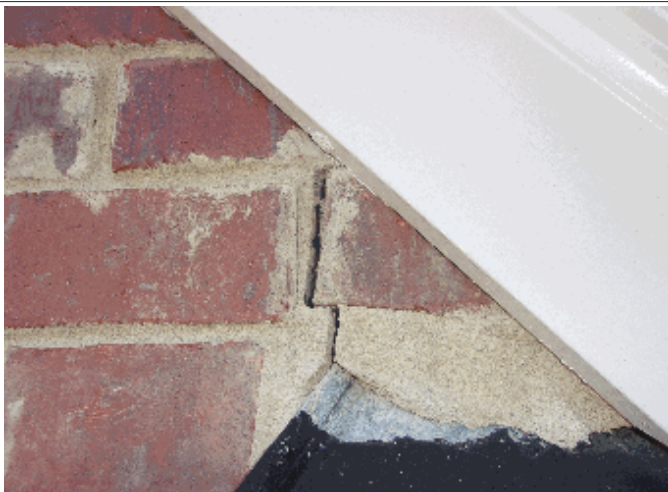
Exterior: Crack above the porch roof should be sealed

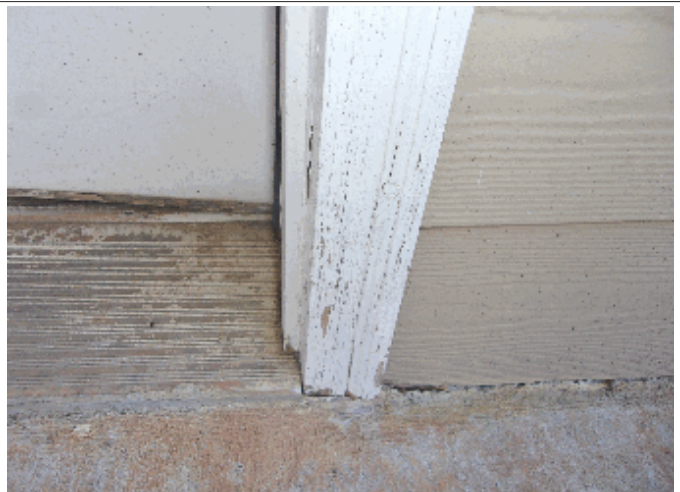
Exterior: Trim on several doors/windows need to be painted

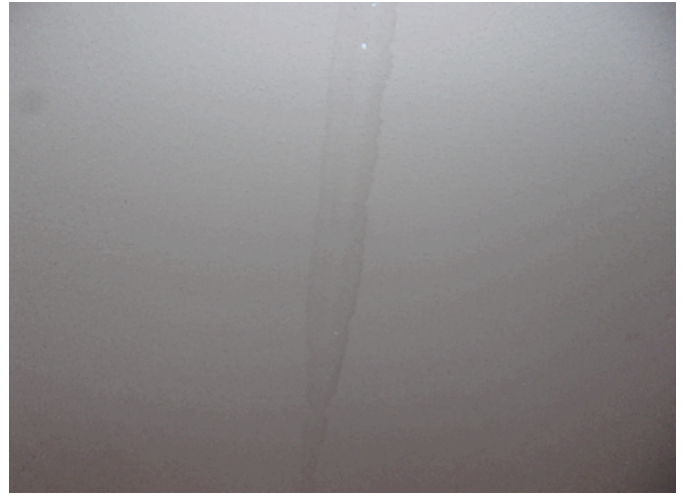
Exterior: Stains on the garage ceiling do not appear to be from an active leak

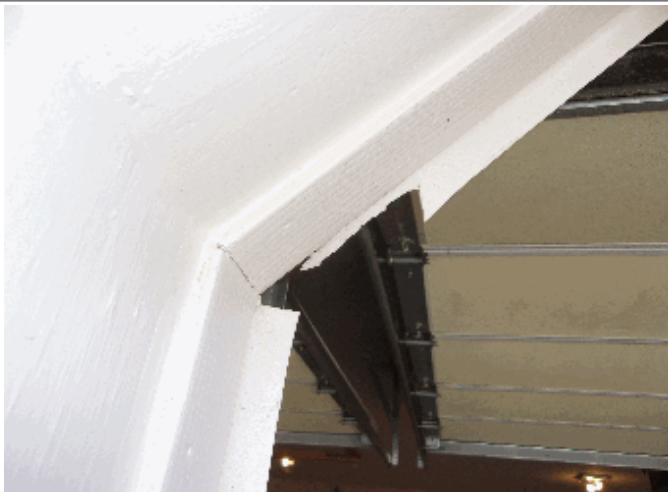
Exterior: Minor damage to garage door seal

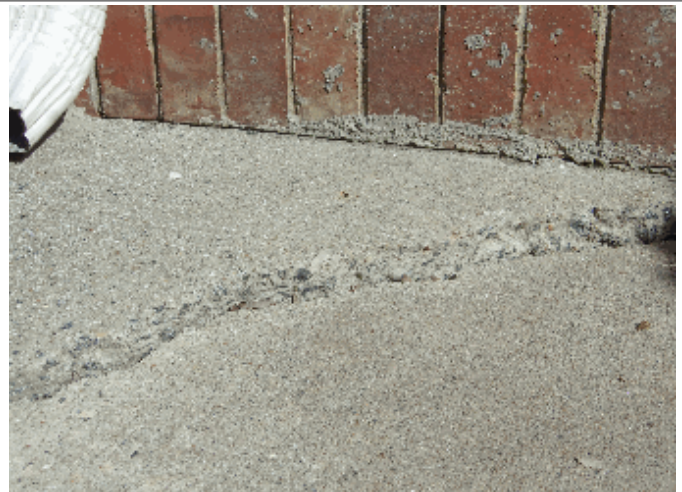
Exterior: Walkway on the right side of the house has settled; this could be a trip hazard

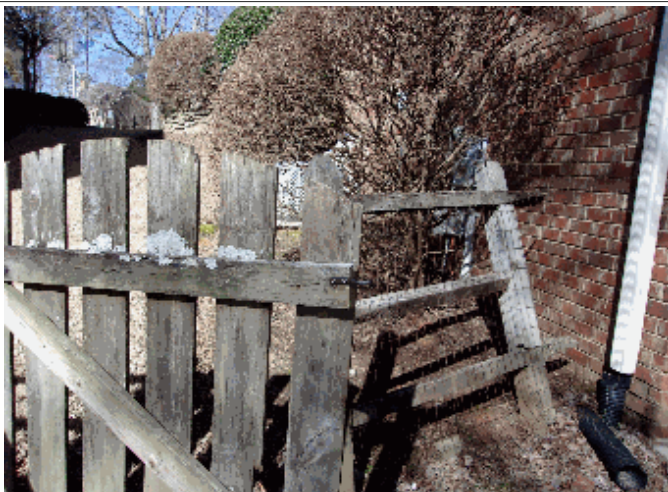
Exterior: Fence gate on the right does not open/shut properly and the posts are rotted

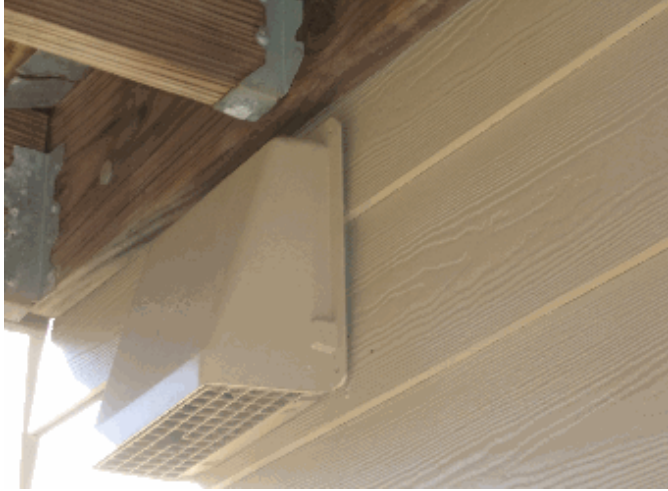
**Exterior: We recommend sealing around all vents on the outside and cleaning the dryer vent prior to use**
